Monthly Meeting: Tuesday, 10 May 2022
Mr Griffin's Ill-fated City Railway
with Mark Butz

A 1922 image of Griffin's broken railway trestle bridge has always stuck with Mark Butz as a symbol of how we can underestimate the natural environment. It also began his interest in the whole ill-fated railway idea and in how it came to disappear largely from view.

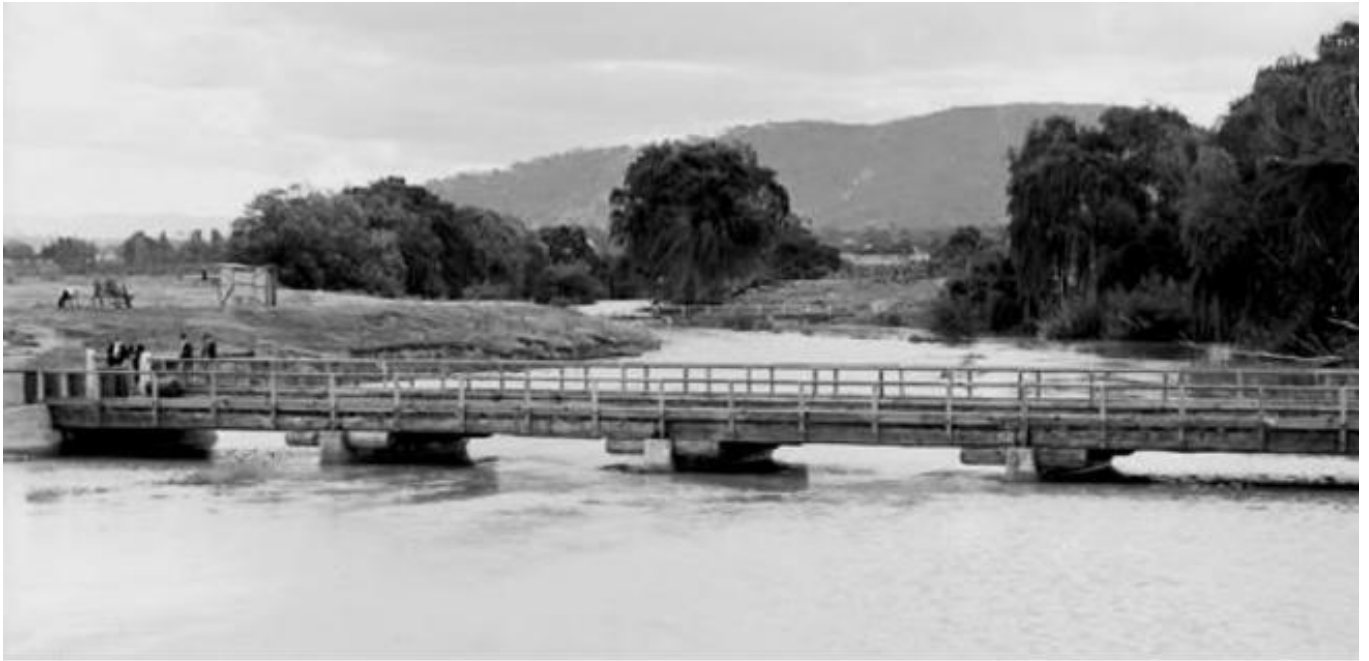
*Photograph courtesy of the National Archives of Australia
NAA: A3560, 4896*

The low level bridge over Scott's Crossing ran between near where the National Gallery is located to the area of Blundell's Cottage and St Johns. Of greater railway interest is the low level bridge behind it, which carried loads from the Yarralumla Brickworks to building sites in Civic.

Despite the loss, city construction work continued with a new light tramway connection in 1924-25 crossing the Molonglo close to Scott's Crossing. This was an offshoot of the narrow gauge tramway that connected the Powerhouse, Parliament House and the Brickworks at Yarralumla.

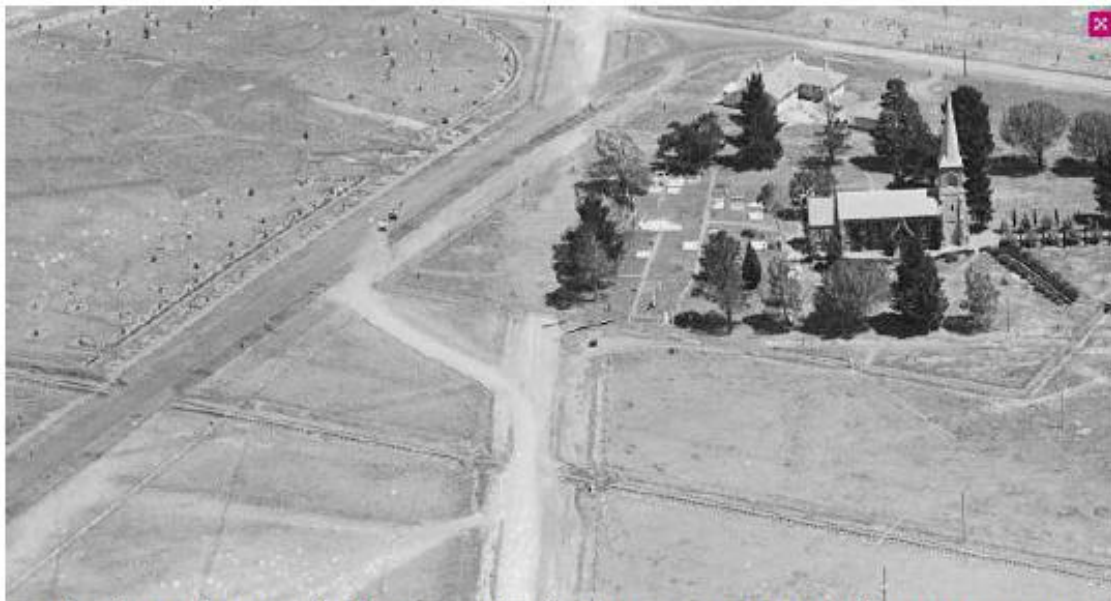
Source: [Fairfax archive of glass plate negatives, National Library](#)

When the Scott's Crossing bridge was completed in January 1929, a major road improvement program was underway. That may explain the two machines on the road opposite what is now the Anzac Parade entrance to St John's graveyard. For Mark, this is another of the 'little-known images' of the railway (foreground) discovered recently. It was catalogued as, 'Aerial view of a cathedral, Canberra, ca. 1920s'.

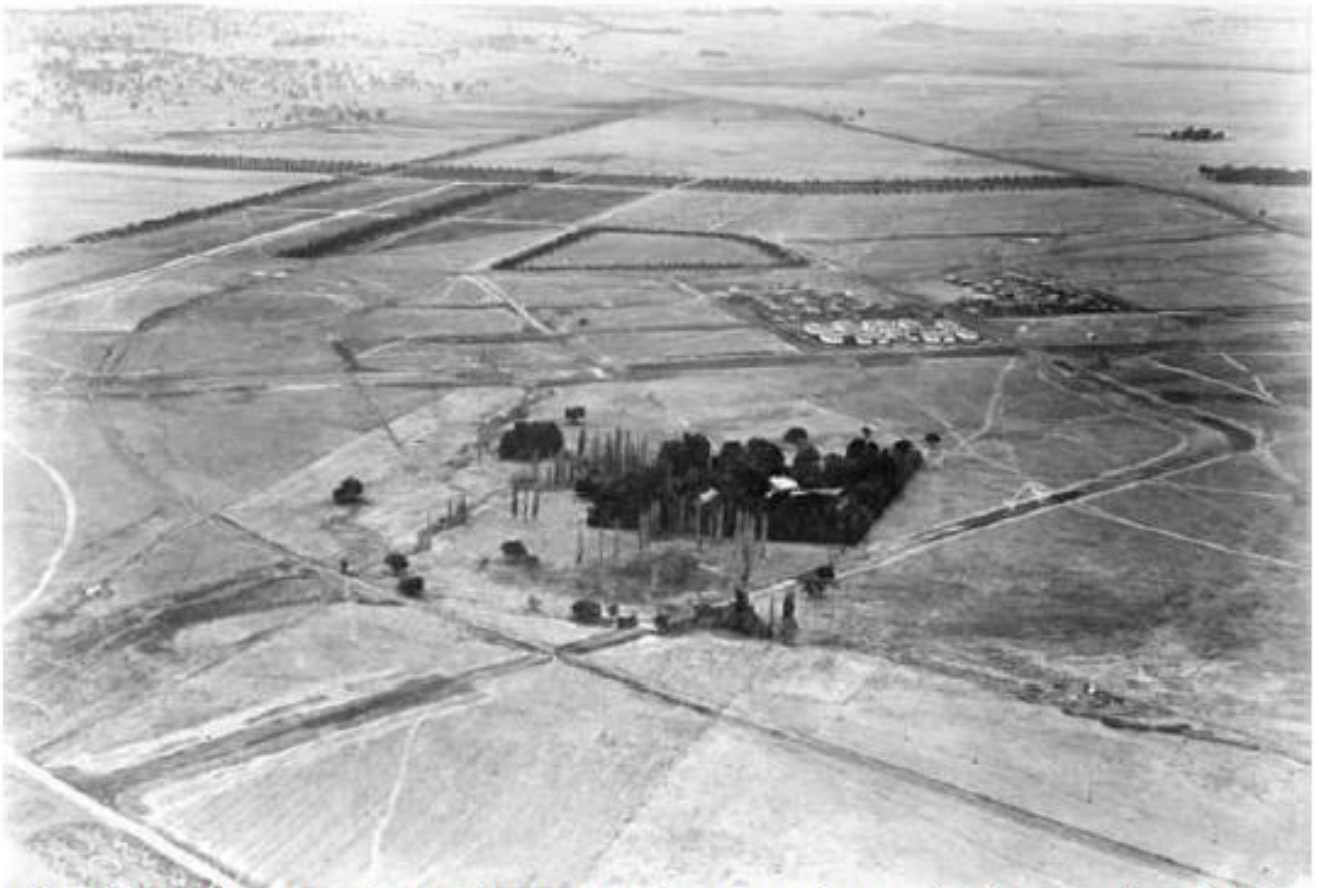
Source: National Archives of Australia, NAA: A3560, 1150

This Mildenhall image complements the one on our front cover, showing the railway stretching from the right foreground, around Glebe House, to a terminus on what is now Mort Street, Civic. Gorman House, on Ainslie Avenue, is visible behind and to the right of Glebe House, as are plantings around what is now the Rugby League Club and Oval, with a young Haig Park across the mid-distance.

The line to the city was opened for goods traffic in 1921. It terminated at a platform and three loop sidings in Civic Centre, the platform site being in modern Garema Place.
